Flight Test Experience and Controlled Impact of a Large, Four-Engine, Remotely Piloted Airplane

Robert W. Kempel and Timothy W. Horton

August 1985

National Aeronautics and
Space Administration

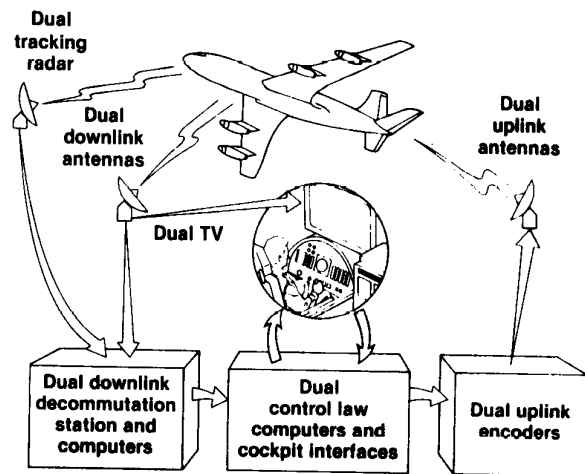
Figure 4. Controlled Impact Demonstration Ground Remotely Piloted Vehicle Control System

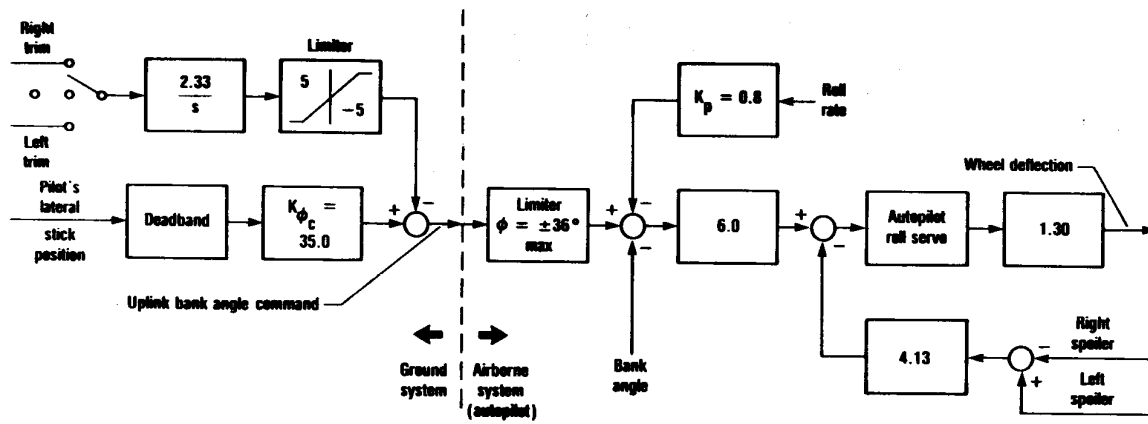
(a) Ground to Wheel Command Path

(b) Wheel to Aileron and Spoiler Command Path

Figure 7. Controlled Impact Demonstration Ground and Airborne Roll Control System

The ground-based and onboard autopilot control laws for the roll axis are shown in Fig. 7. The RPV pilot commanded roll attitude of the aircraft proportional to the lateral displacement of the control stick in the ground-based cockpit. The pilot inputs went through a small deadband and generated commands which were uplinked to the roll axis of the onboard autopilot. Full deflection of the roll stick (± 10.16 cm (± 4 in.)) commanded $\pm 35^\circ$ of bank angle.

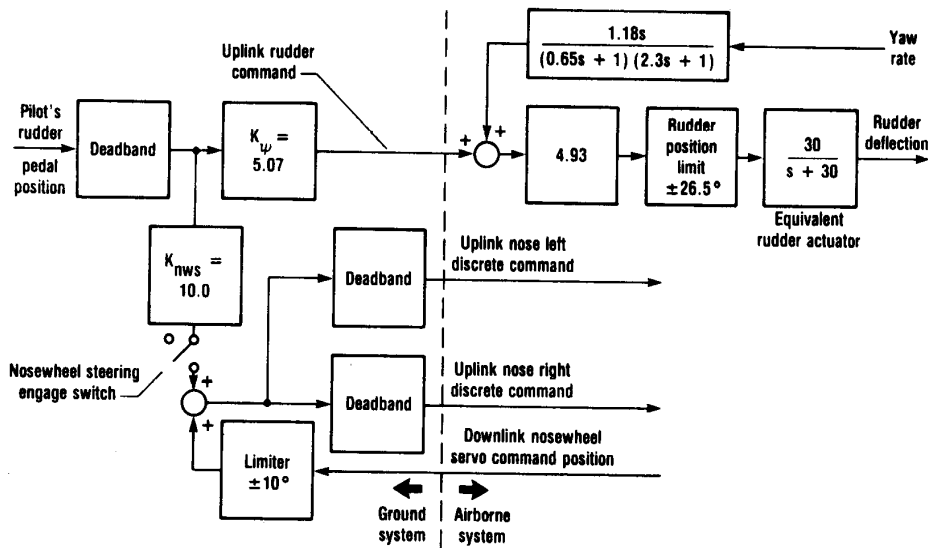
Figure 8. Controlled Impact Demonstration Ground and Airborne Yaw Control System

The RPV pilot commanded rudder to the B-720 aircraft through the yaw damper. The RPV rudder control system is shown in Fig. 8. The rudder pedal position signal was passed through a deadband, and a rudder command proportional to pedal deflection was uplinked to the airplane. Full rudder pedal commanded $\pm 25^\circ$ of rudder deflection.

A diagram representing the implementation of the ground-based cockpit's nosewheel steering system is also shown in Fig. 8. The RPV pilot generated a nosewheel position command that was proportional to rudder pedal displacement when the nosewheel steering was engaged. This command was then compared to the downlinked nosewheel servo-position command. A nose-left or nose-right discrete command was uplinked to the onboard RPV nosewheel steering system motor. This motor then

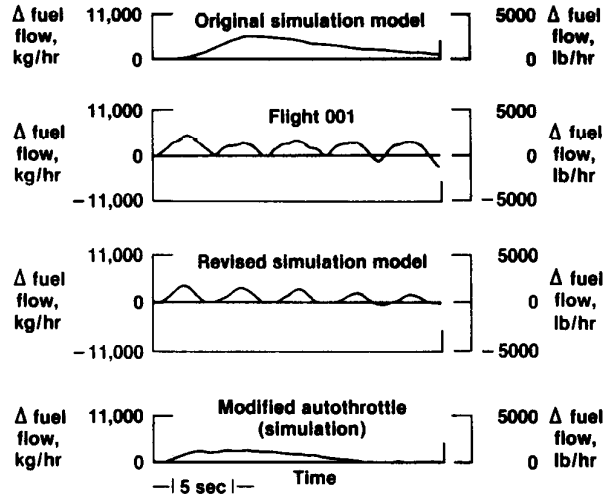
Figure 10. Comparison of Flight and Simulation Engine Fuel-Flow Response to an Autothrottle Step Input

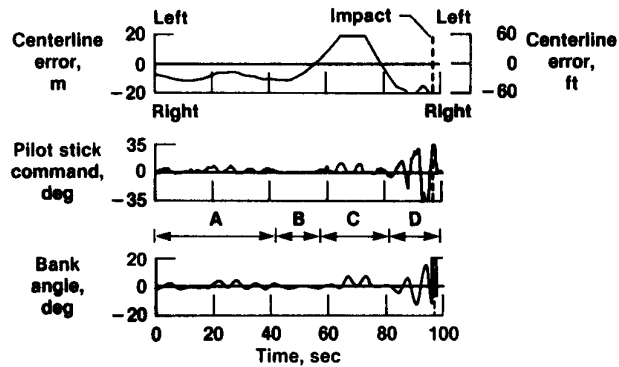
Figure 11. Lateral-Directional Time Response From 498 m (1630 ft) AGL to Impact

Some of the pertinent lateral-directional parameters near impact are shown in Fig. 11 and the longitudinal parameters are shown in Fig. 12. The time histories are broken into four regions (A to D), based on lateral activity, as shown in the figures.

Region B. In region B, the RPV pilot stopped making any significant lateral corrections for about 10 sec. This occurred while he was working the longitudinal task since the altitude error was increasing significantly immediately before region B, and was reduced to an acceptable level by the end of the region B. It could have also been caused, in part, from the need to transition between the TV visual display and the cockpit instruments in order to cross check the validity of the guidance information. Whatever the reason, during this time period without any pilot inputs, the roll bias produced a left turn (about a 2° bank). This, in turn, caused the lateral deviation to start moving rapidly to the left (rapidly in terms of the 4.6 m (15 ft) constraint). The actual crossrange drift rate was about 0.9 m/sec (3 ft/sec) at the end of region B.
